# ARTIFICIAL REEFS FOR MITIGATION

## A Brief Summary

Environmental Planning and  
Community Resilience Division

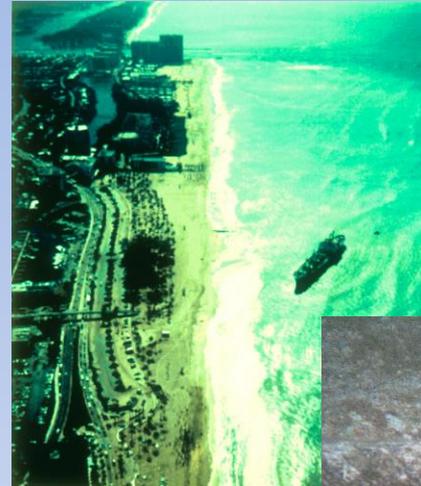
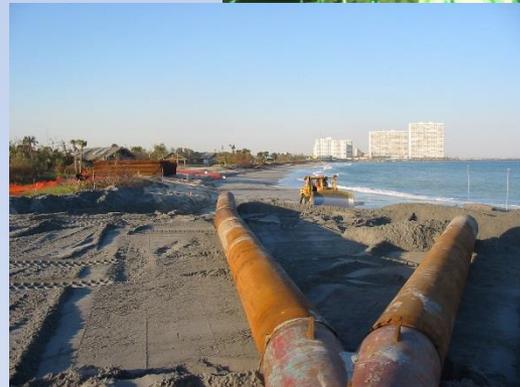
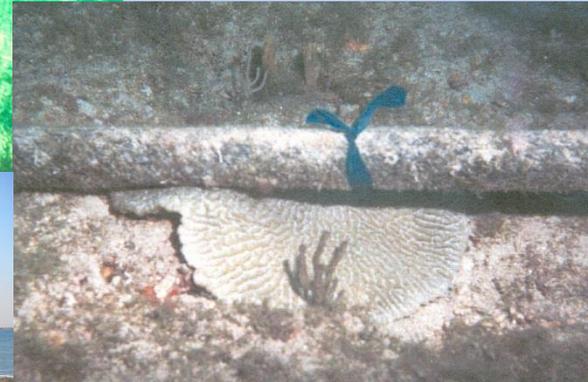
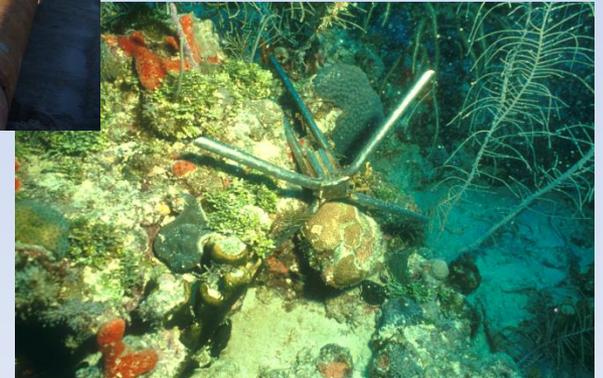
# Types of Damage to Coral Reefs

Anchor damage

Beach nourishment

Pipelines and cable

Vessel groundings

Water quality

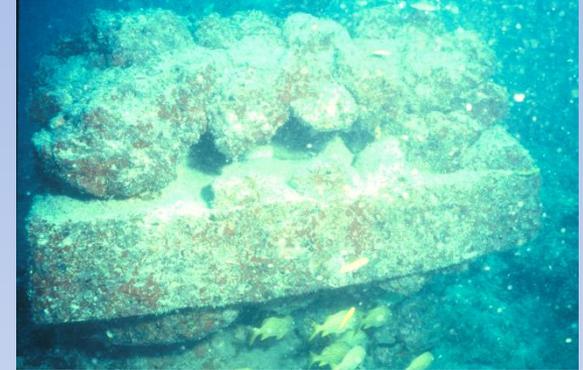
Mitigation – Offset known impacts

Substrate → Artificial reefs

Biological community

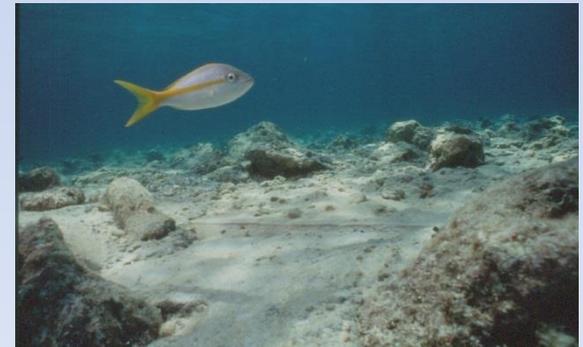
Restoration – Create original condition

Substrate → Re-create framework

Biological community

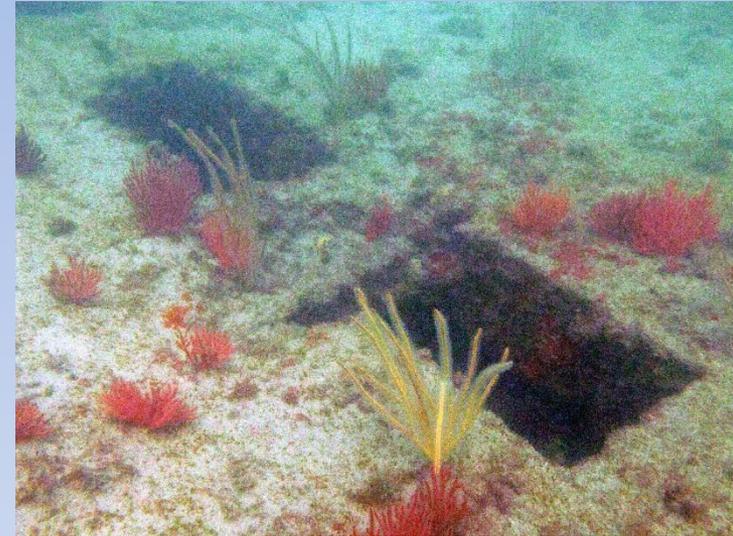
# Mitigation in Martin County

- Beach nourishment project
- Deployed in 2000
- Material of opportunity (bridge)
- 3 sites
  - Reef A: 104 concrete & steel sections
  - Reef B: 150 concrete & steel sections
  - Reef C: 164 concrete & steel sections
- Single monitoring event

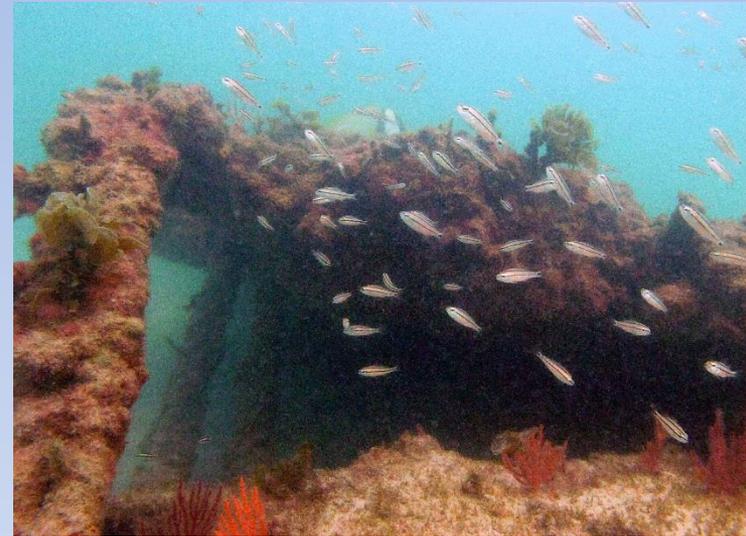
# Martin County Nearshore Artificial Reef

After 2 yrs soak time:

- Reef A
  - fish species – 15
  - benthic species – 7
- Reef B
  - fish species – 21
  - benthic species – none reported
- Reef C
  - fish species – 18 (1 goliath)
  - benthic species – 10

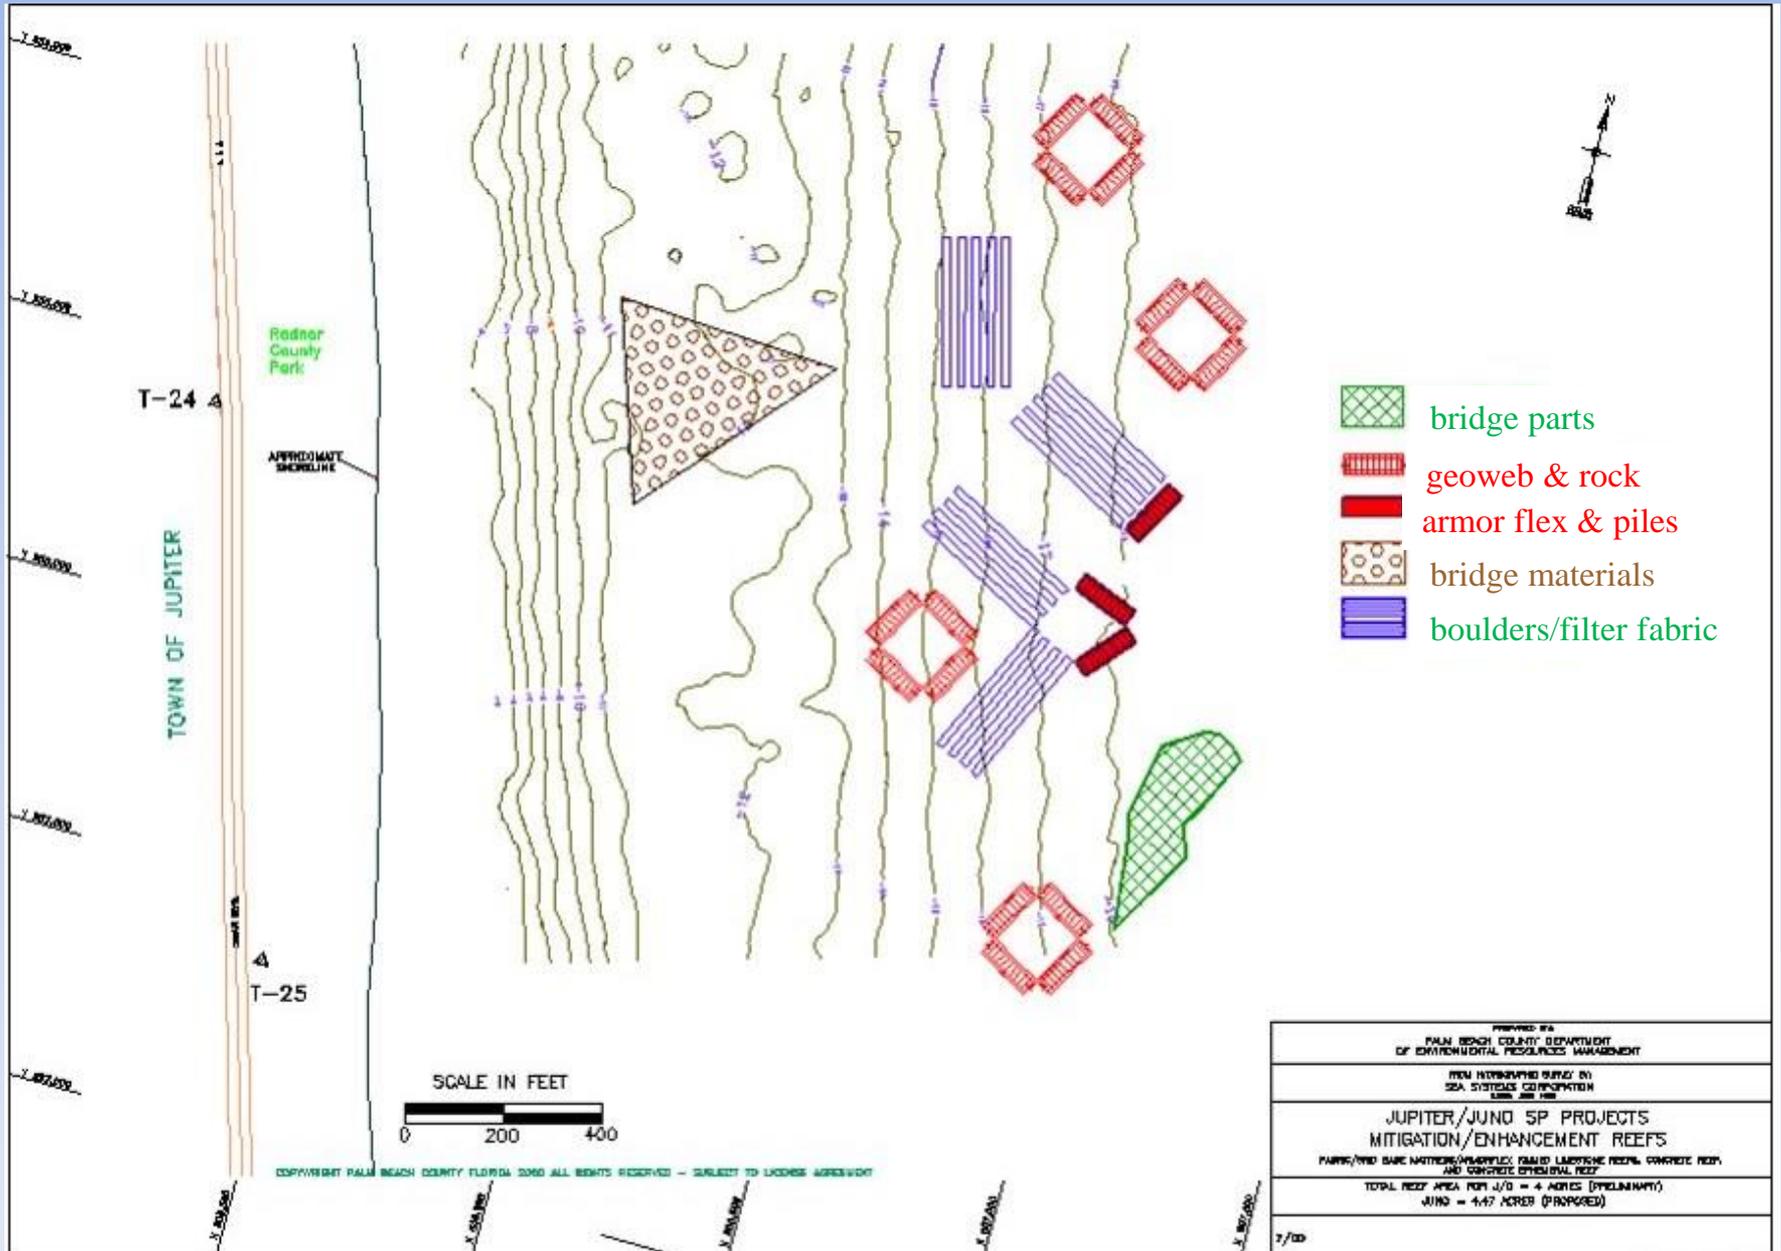
# Diamondhead Radnor Mitigation Reefs

Geogrid &  
Limestone Boulders  
2000

Filter Fabric and  
Limestone Boulders  
1998 -1999

Royal Park  
Bridge Rubble  
2000

Barge 2001

Donald Ross  
Bridge Rubble  
1998-1999

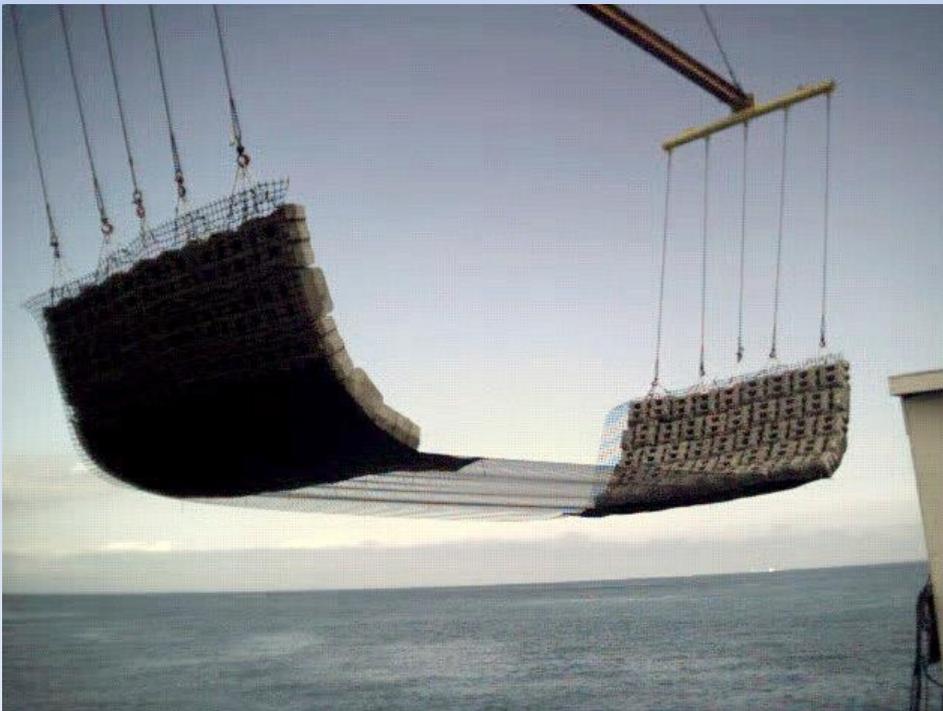
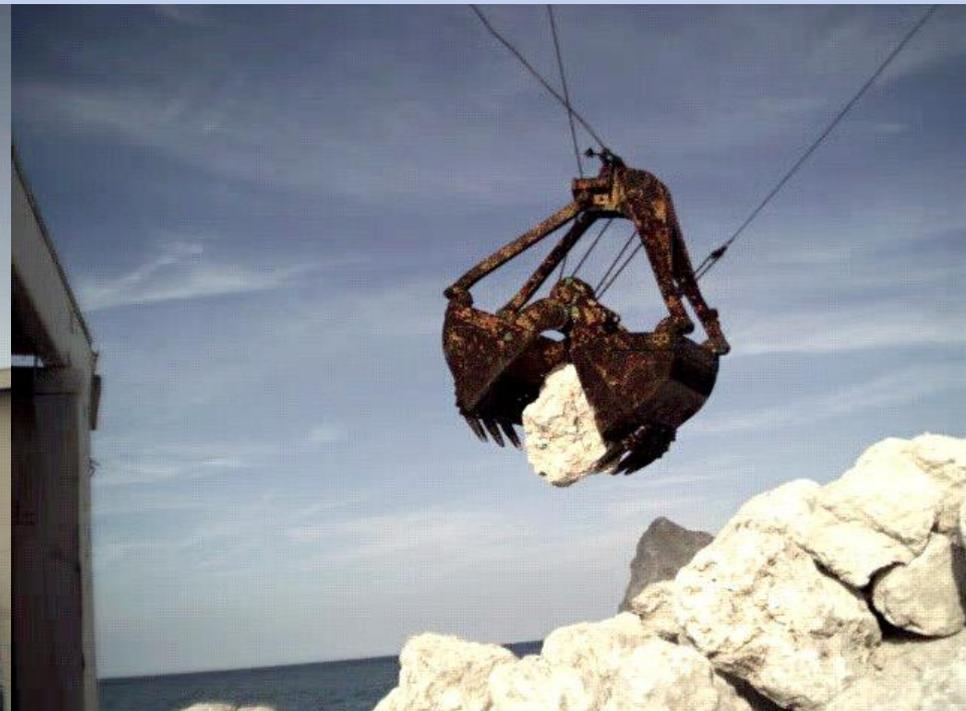
# Diamondhead Radnor Mitigation Reefs

- 14-20 ft water depth
- 15,000 tons rock
- 3-4 acre area
- \$2 - \$3 million
- no rock underburden
- added armor flex with Kevlar mesh
- scouring continues

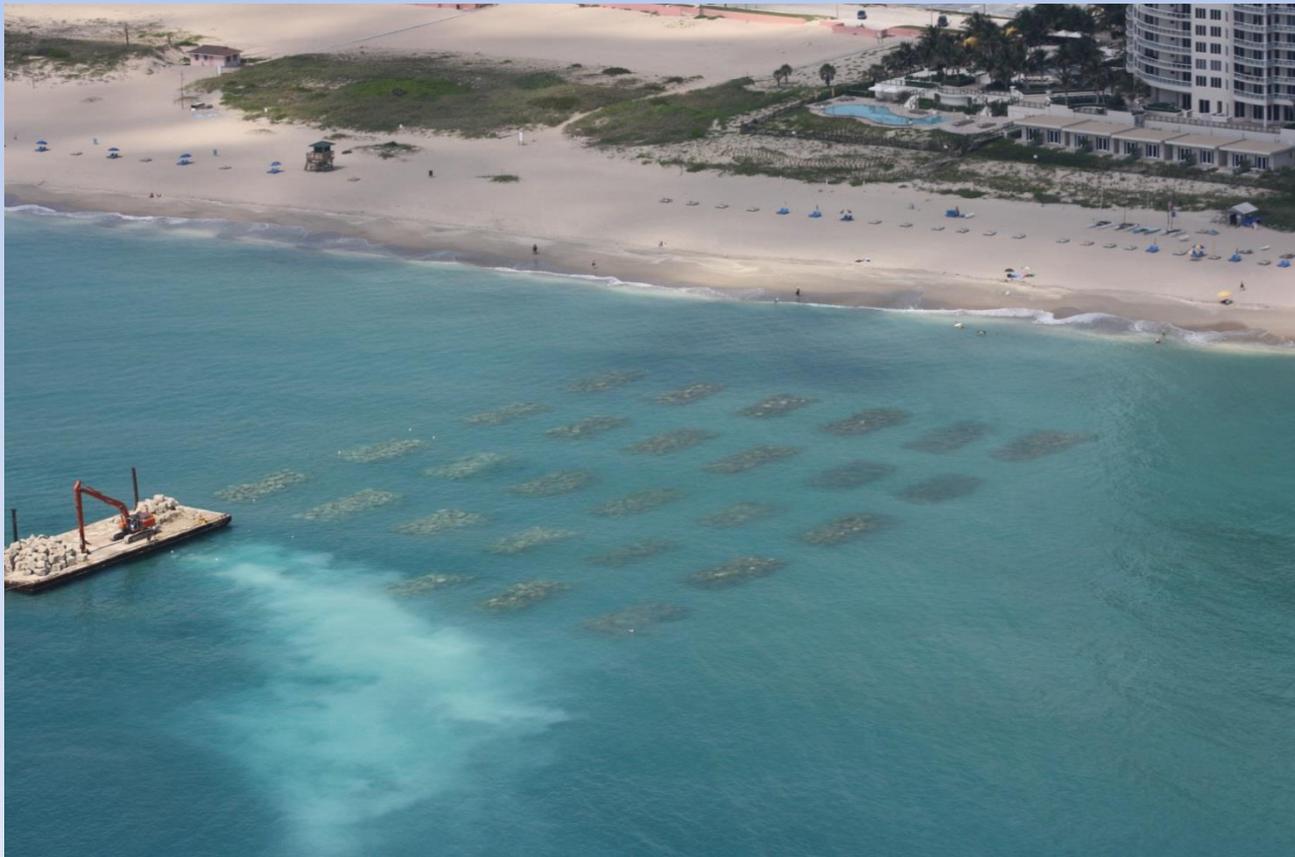
# Singer Island Mitigation Reef - 2009

Nearshore impact due to beach nourishment

Ephemeral (50%) exposed at any time

- 45-50 reefs
- close to shore
- 2 acres
- \$1.2 million

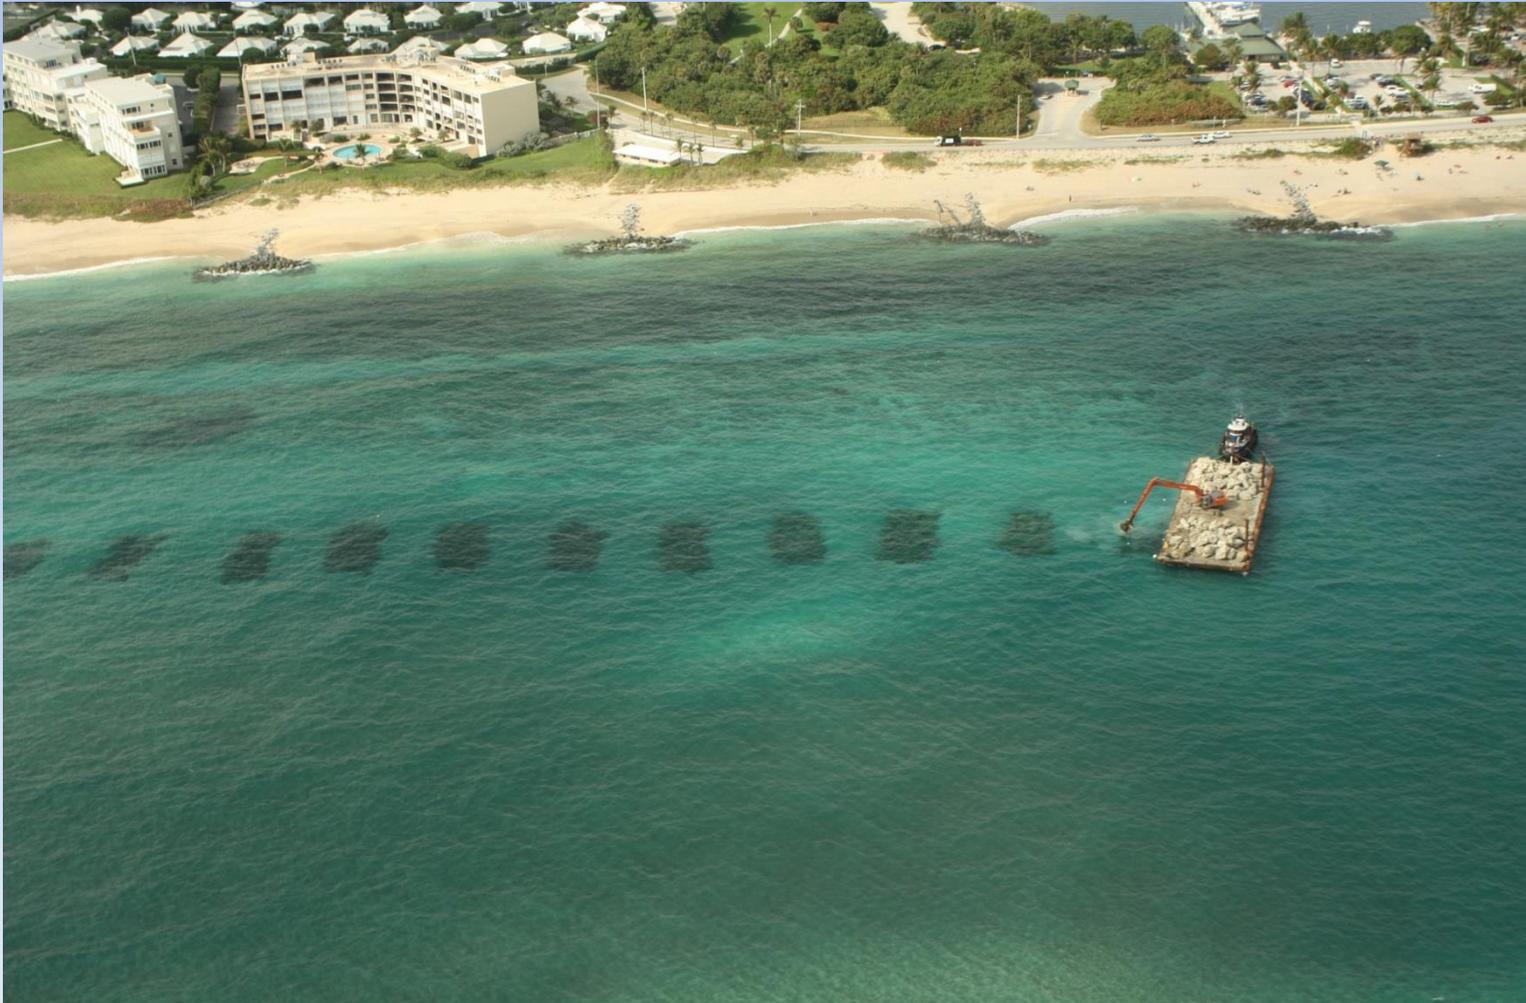
# Ocean Ridge - 2009

## Beach Nourishment Mitigation

# Ocean Ridge Reefs

- 60 pods
- 2.5 acres
- \$1.5 million

Each pod is approximately  
20 ft. by 40 ft.

29 pods extend north to  
south

31 pods in a cluster at the  
south end

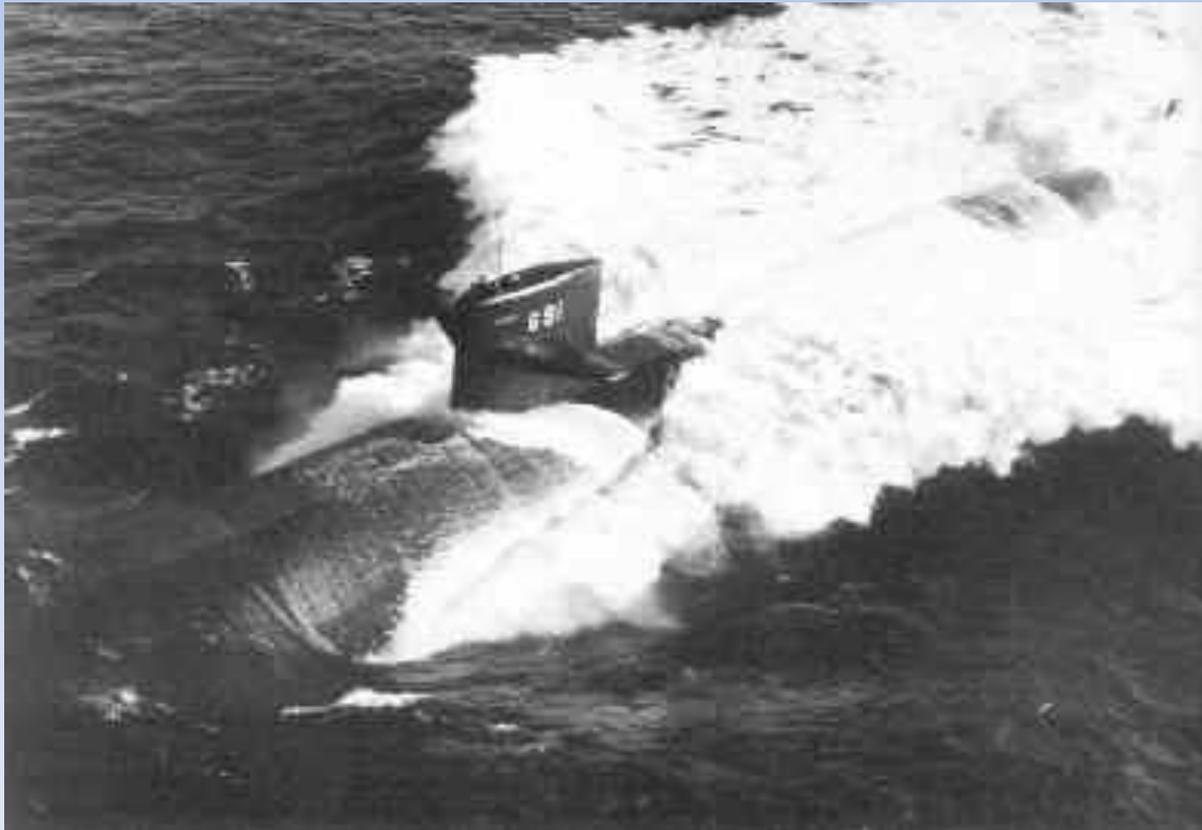
1993, a nuclear submarine grounded on a reef (d=25 ft),  
leaving a deep trench, scraped substrate, and piles of rubble

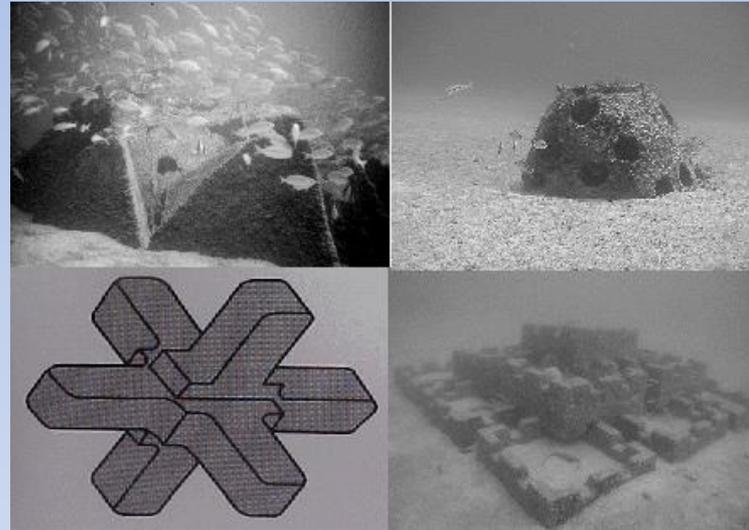
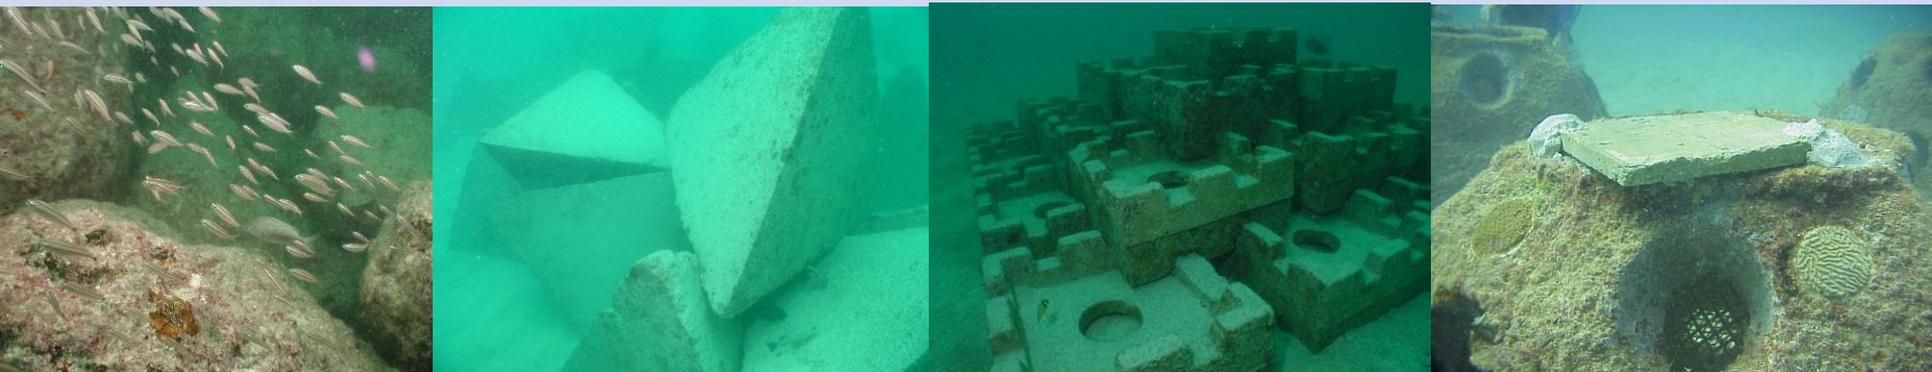
- Deploy 300 tons of limestone boulders (Mt. Dania),
- 150 tons of concrete tetrahedrons,
- 50 Warren Modules,
- 100 Ajacks,
- 160 Reef Balls (for research),
- Research program and monitoring

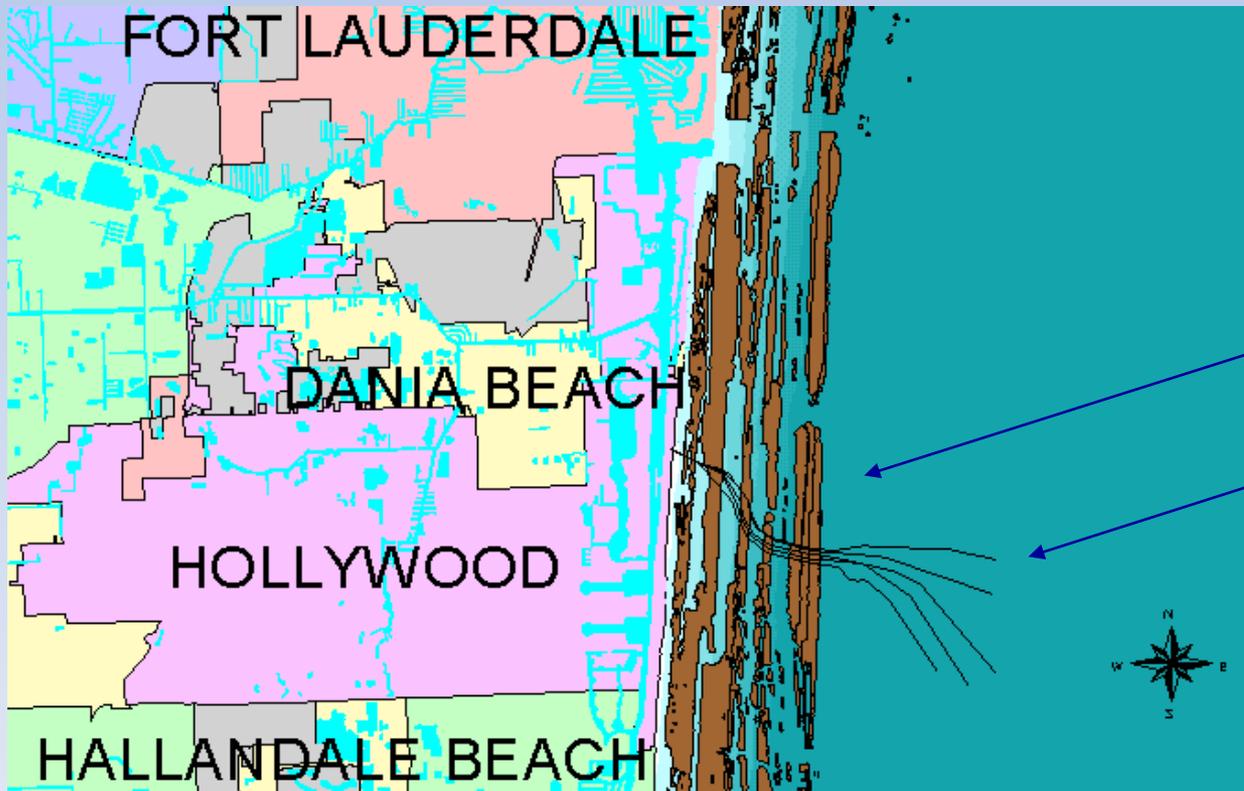
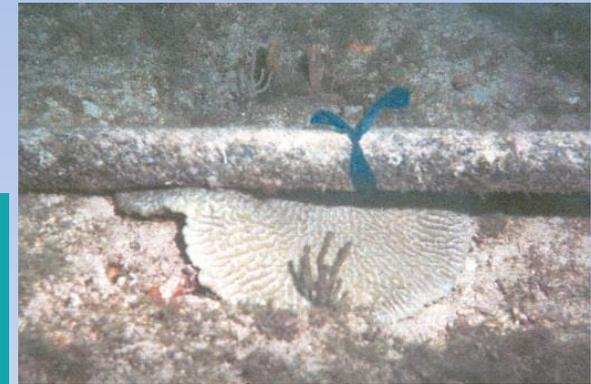
5 fiber-optic cables installed over parallel reef tracts

reef

fiber-optic cables

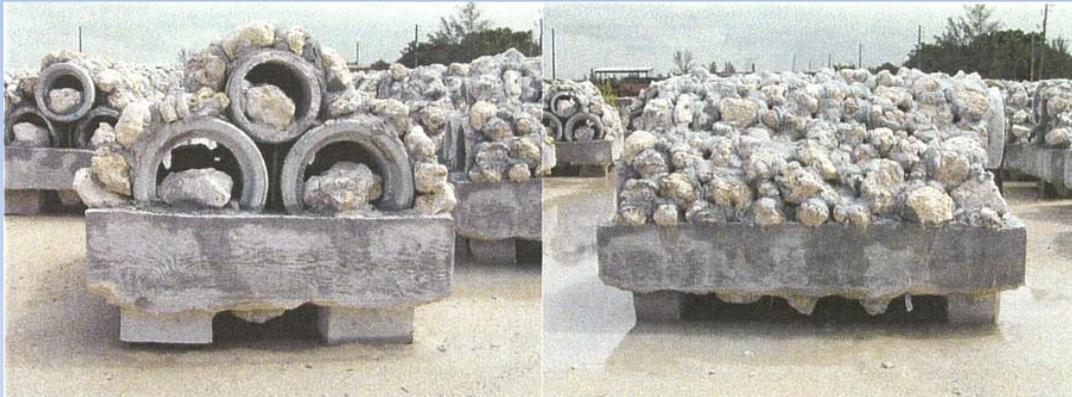
30 DERM Modules deployed to mitigate for lost colonies

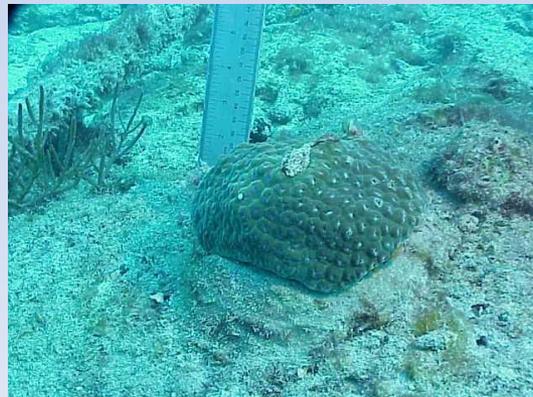
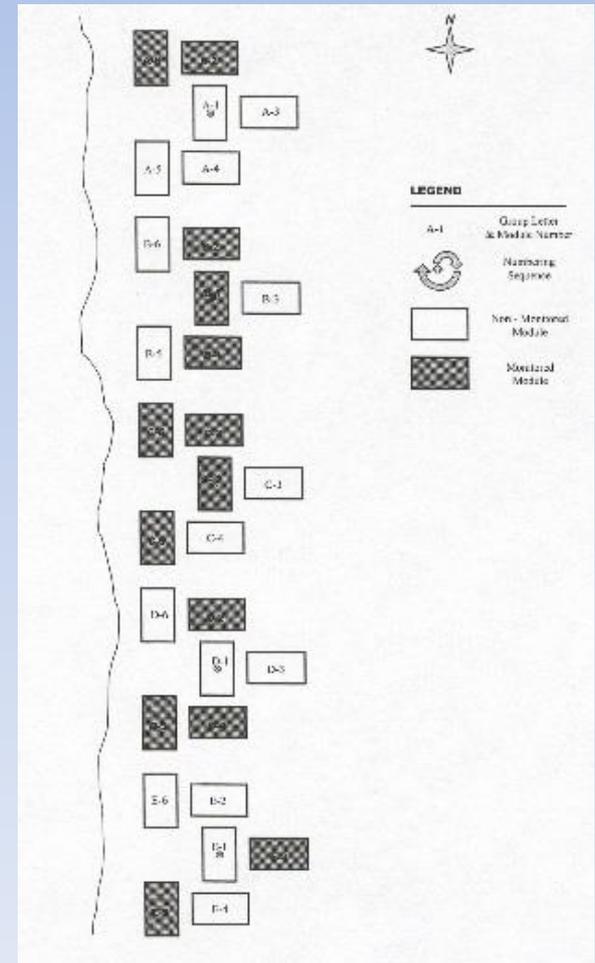
160 loose coral colonies were re-attached

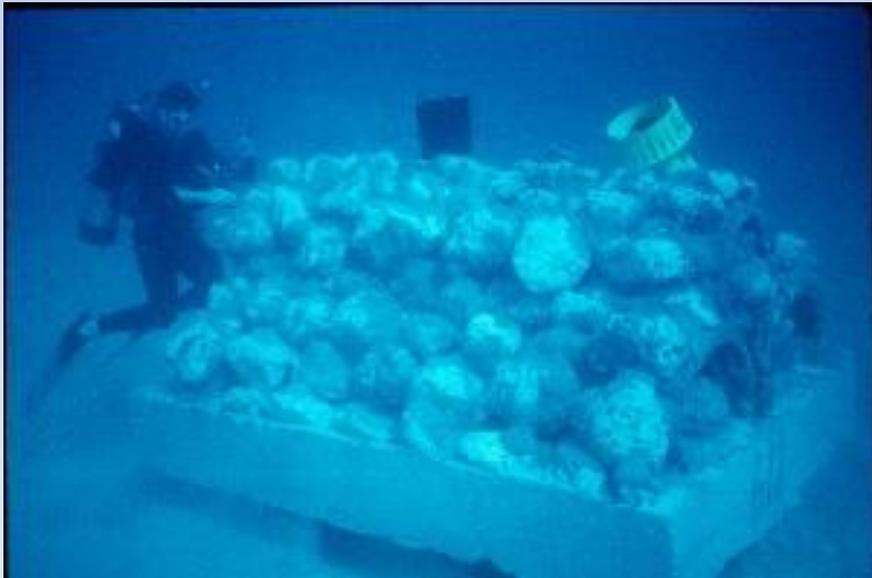
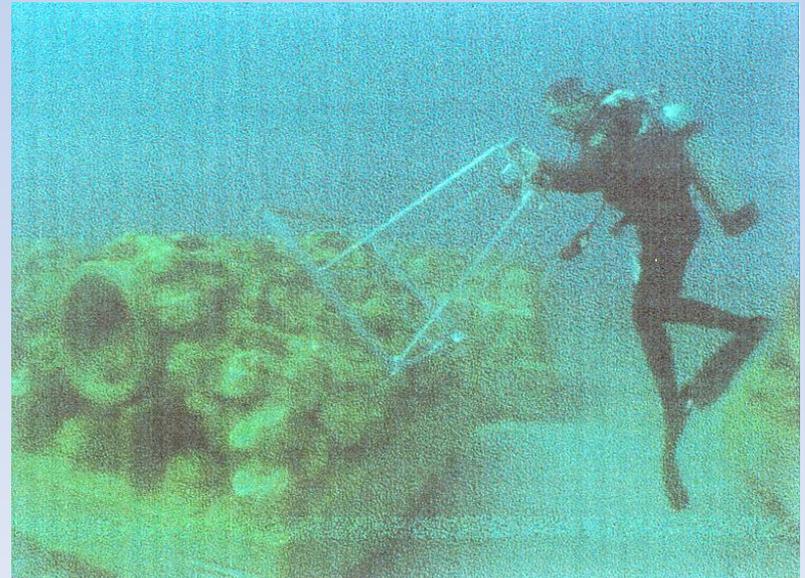
5 yrs post-deployment

- stony corals – 18 spp, high recruitment and density
- fishes – 150 spp observed

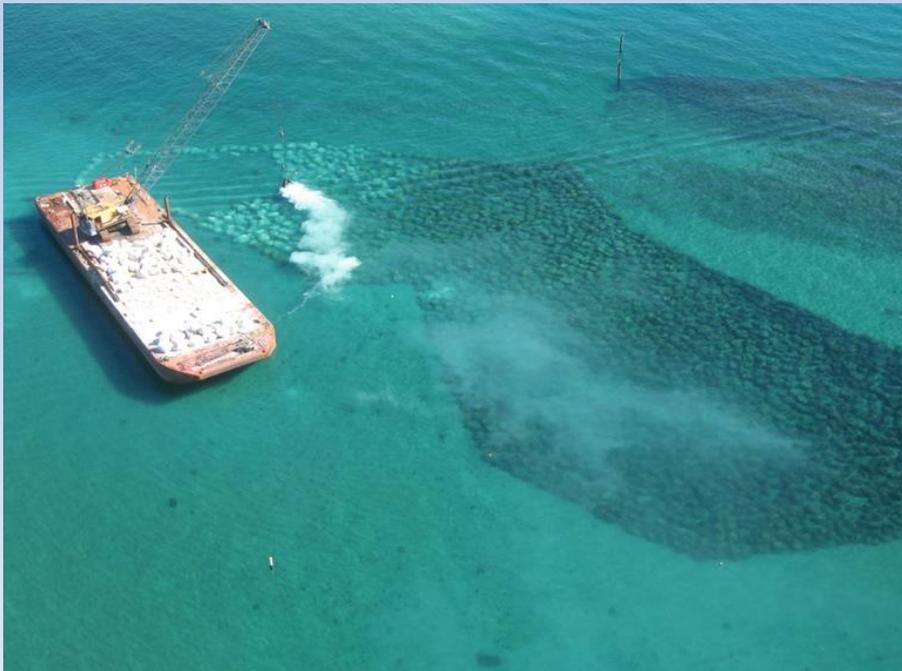
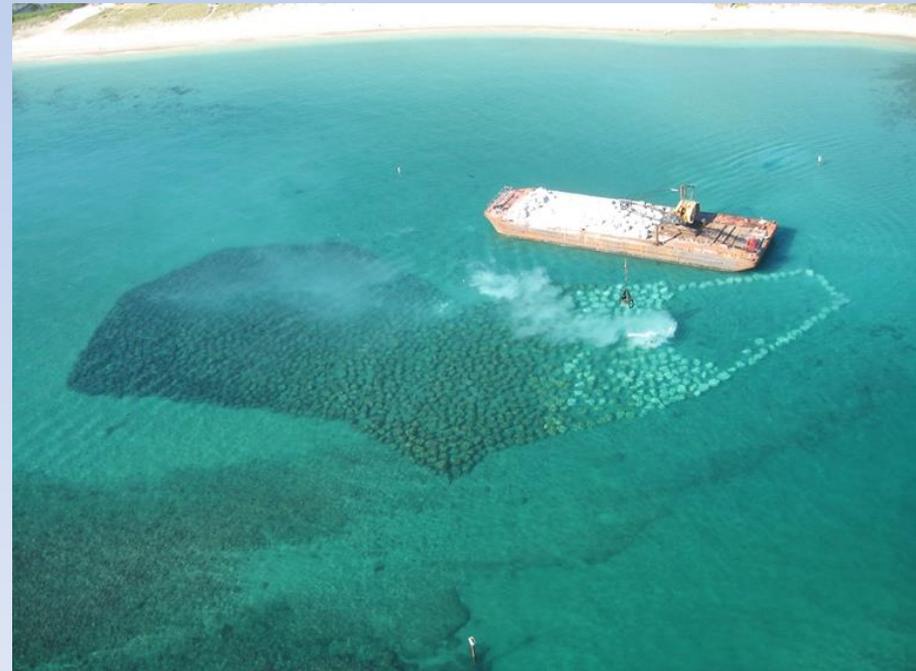
# Reef Impacts from Cable Drag

Sheared sponges and octocorals

Mitigated with limestone boulders

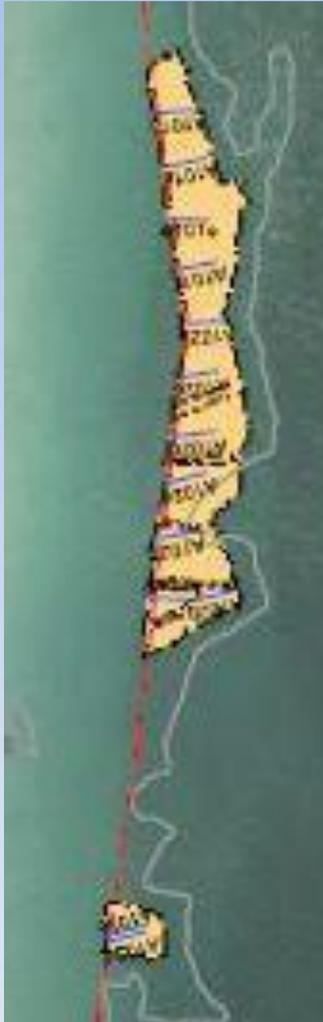
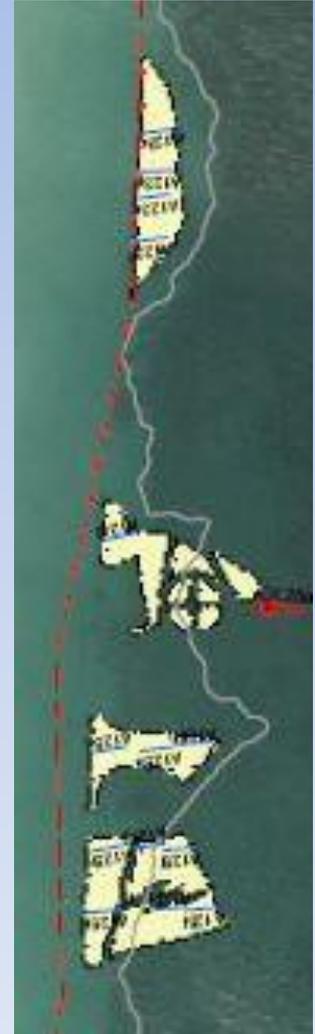
# Segment III Beach Nourishment Mitigation

8.9 acres of limestone boulders deployed

Fish spp richness & abundance greater on mitigation

Benthic assemblage significantly different

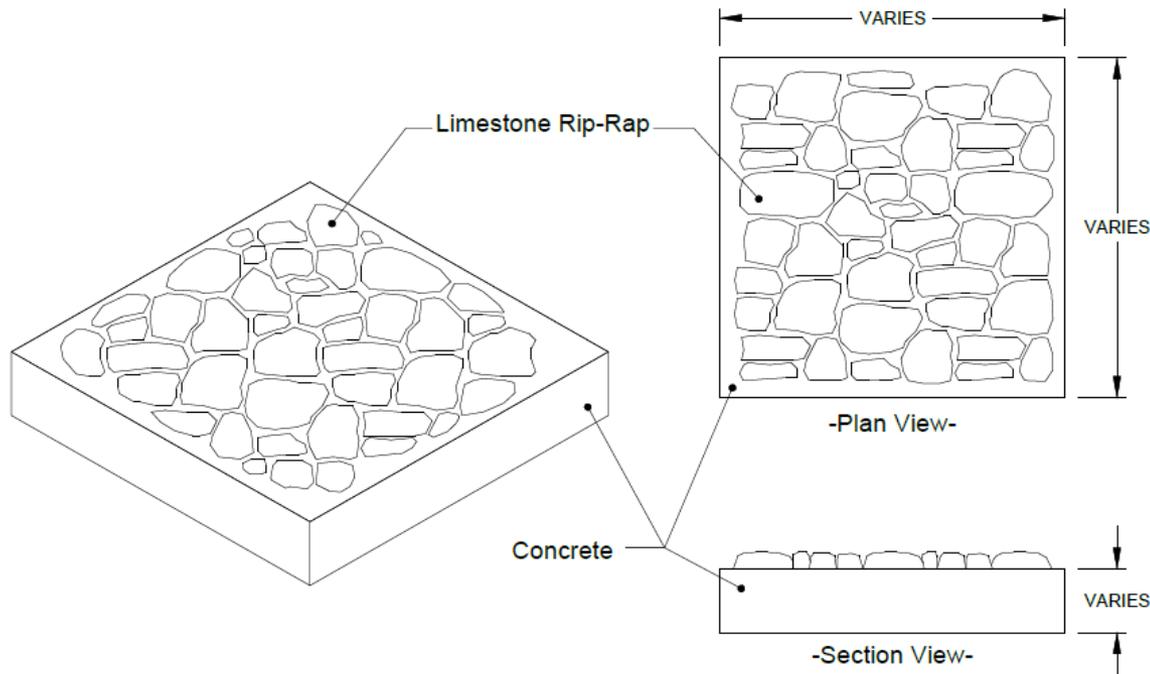
# Segment II Beach Nourishment Mitigation (proposed)

6.8 acres

4,000-6,000 units

~ 60 sq. ft/module

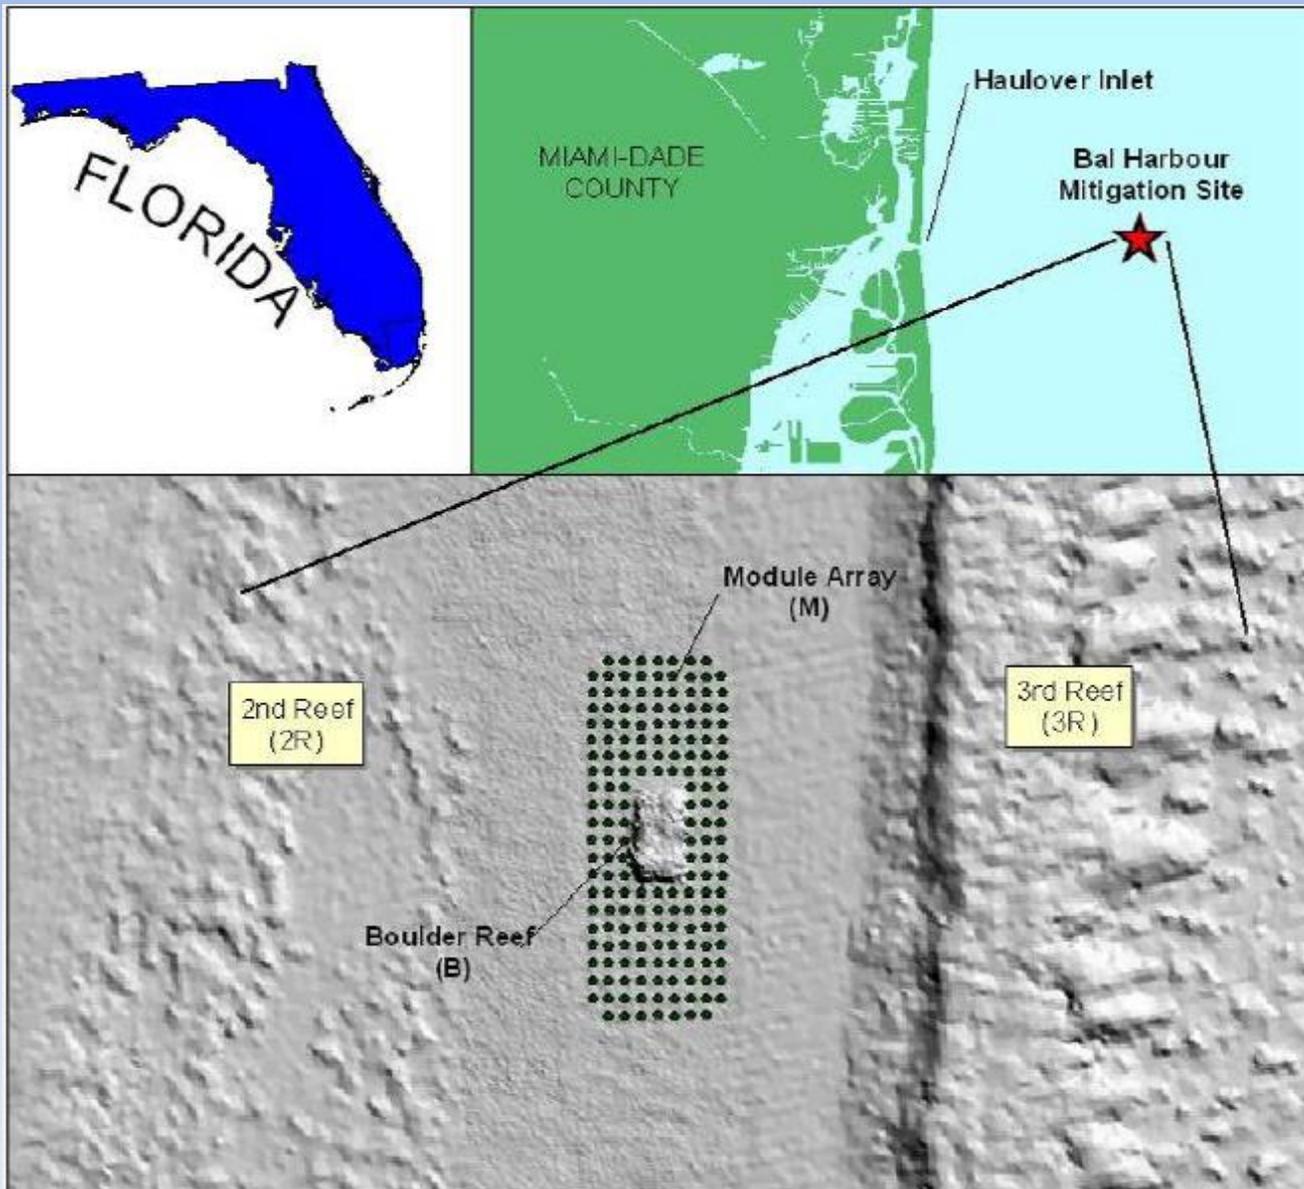
# Bal Harbor Mitigation Site

10 yrs monitoring  
vs natural reef

Benthic community  
approaching  
similarity

Fish assemblages  
remain distinct
